GEOTECHNICAL STRUCTURES: INVESTIGATION OF DRILLED SHAFTS IN HIGHLY EXPANSIVE SOILS

Significant building movement and distress have been observed in the Community Activity Centre (CAC), Building 6576.

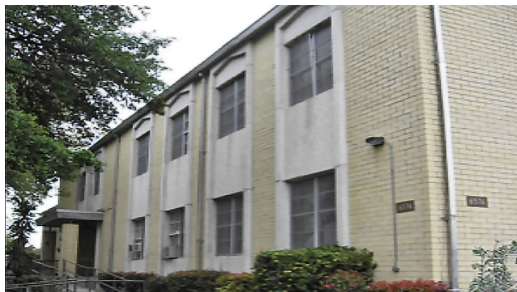
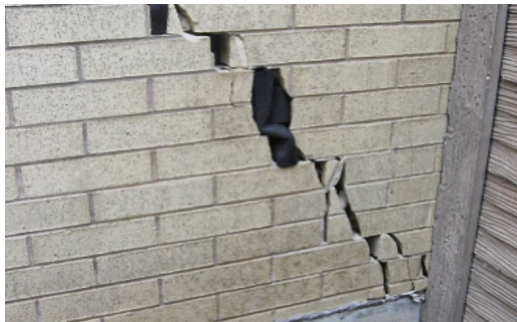
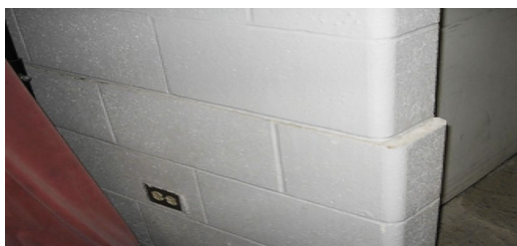
Evidence of significant building movements includes sloping floors and widespread cracking in interior and exterior walls (see Figs 1–3). An interior spot elevation study was performed to assess the location and severity of vertical building movements. Differences in finish floor elevations across the building footprint were found to be more than 305 mm.

Fig. 1. Entrance of CAC building

Fig. 2. CAC broken wall

Fig. 3. CAC shifted wall

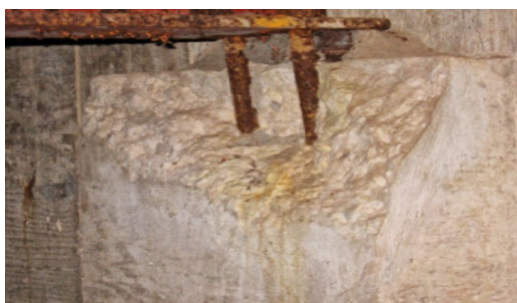
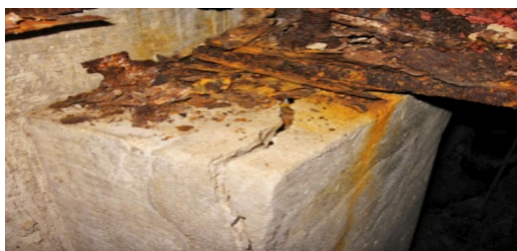
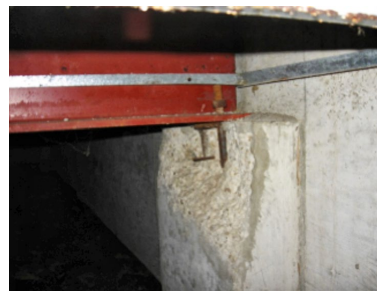
- Around the building perimeter, steel girders supporting floor joists have begun to pull away from the concrete pilasters they bear on (see Figs 4–6). As a result, shear stresses applied thru the anchor bolts have caused the outside face of the pilasters to spall away. In many cases the bearing surface has completely spalled away and the beams are supported solely by bent and corroded anchor bolts which are not well confined in the surrounding concrete. Partial floor collapse due to this condition could occur any time and is more likely under the presence of live load.

Fig. 4. Expose rebar in CAC foundation

Fig. 5. Damage CAC foundation

Fig. 6. CAC foundation

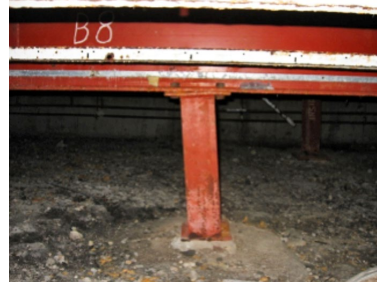
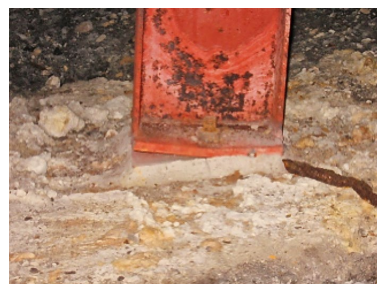
- Building settlements on the north side of the assembly room near the stage have caused underlying steel beams to bend, rotate and shift laterally. The beam rotations and lateral movement has caused the steel stub columns supporting the floor framing to tilt sideways. This creates eccentric support conditions that could result in sudden instability failure of either the beams or columns (see Figs 7–8)

Fig. 7. Bent/shifted CAC foundation

Fig. 8. Bent I-beam supporting column

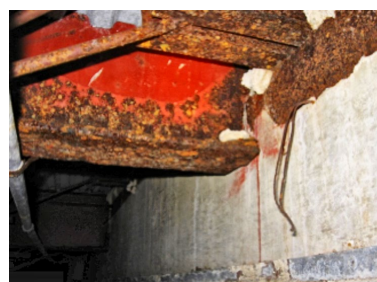
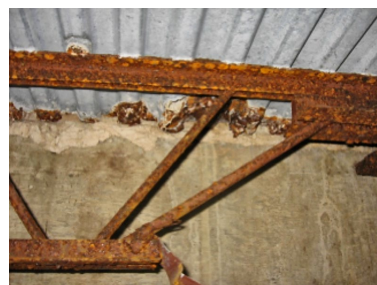
- Under bathrooms in the northwest corner of the building, significant corrosion of steel framing was observed due to long term exposure

to moisture leaking through cracks in the floor slab above. The load carrying capacity of the corroded framing members may be significantly reduced (see Figs 9–10).

Fig. 9. Damaged beams

Fig. 10. Damaged support

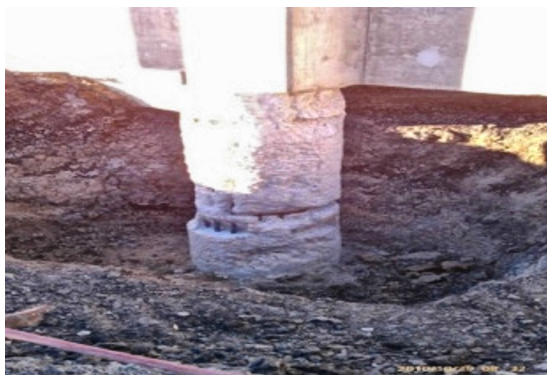
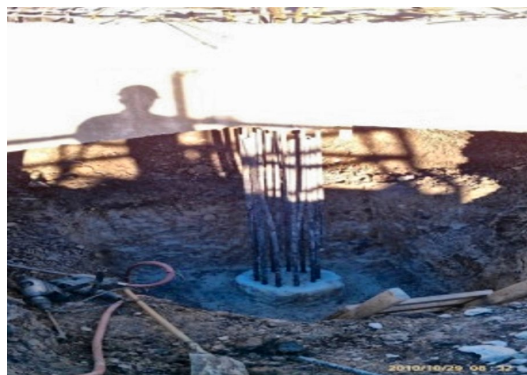
Figures 11 and 12 show defective piers. A poor quality control was kept which lead to 119 of the 125 piers to be defective.

Fig. 11. Exposed rebar in pier

Fig. 12. Grade beam over exposed pier

Pier drilling inspections were carried out by a geotechnical engineer. This is important to correct defective piers. The defective piers were corrected at an early stage using the following practical options: 1) investigation of the installed pier, 2) immediate re-installation before the concrete set up, and 3) rejection of an unacceptable pier required installation of one or more replacement piers at locations that would facilitate load transfer from the structure above.
